MARINE CASUALTY REPORT

GLOMAR JAVA SEA

CAPSIZING AND SINKING

REPORT NO. USCG-16732/0004 HQS-83

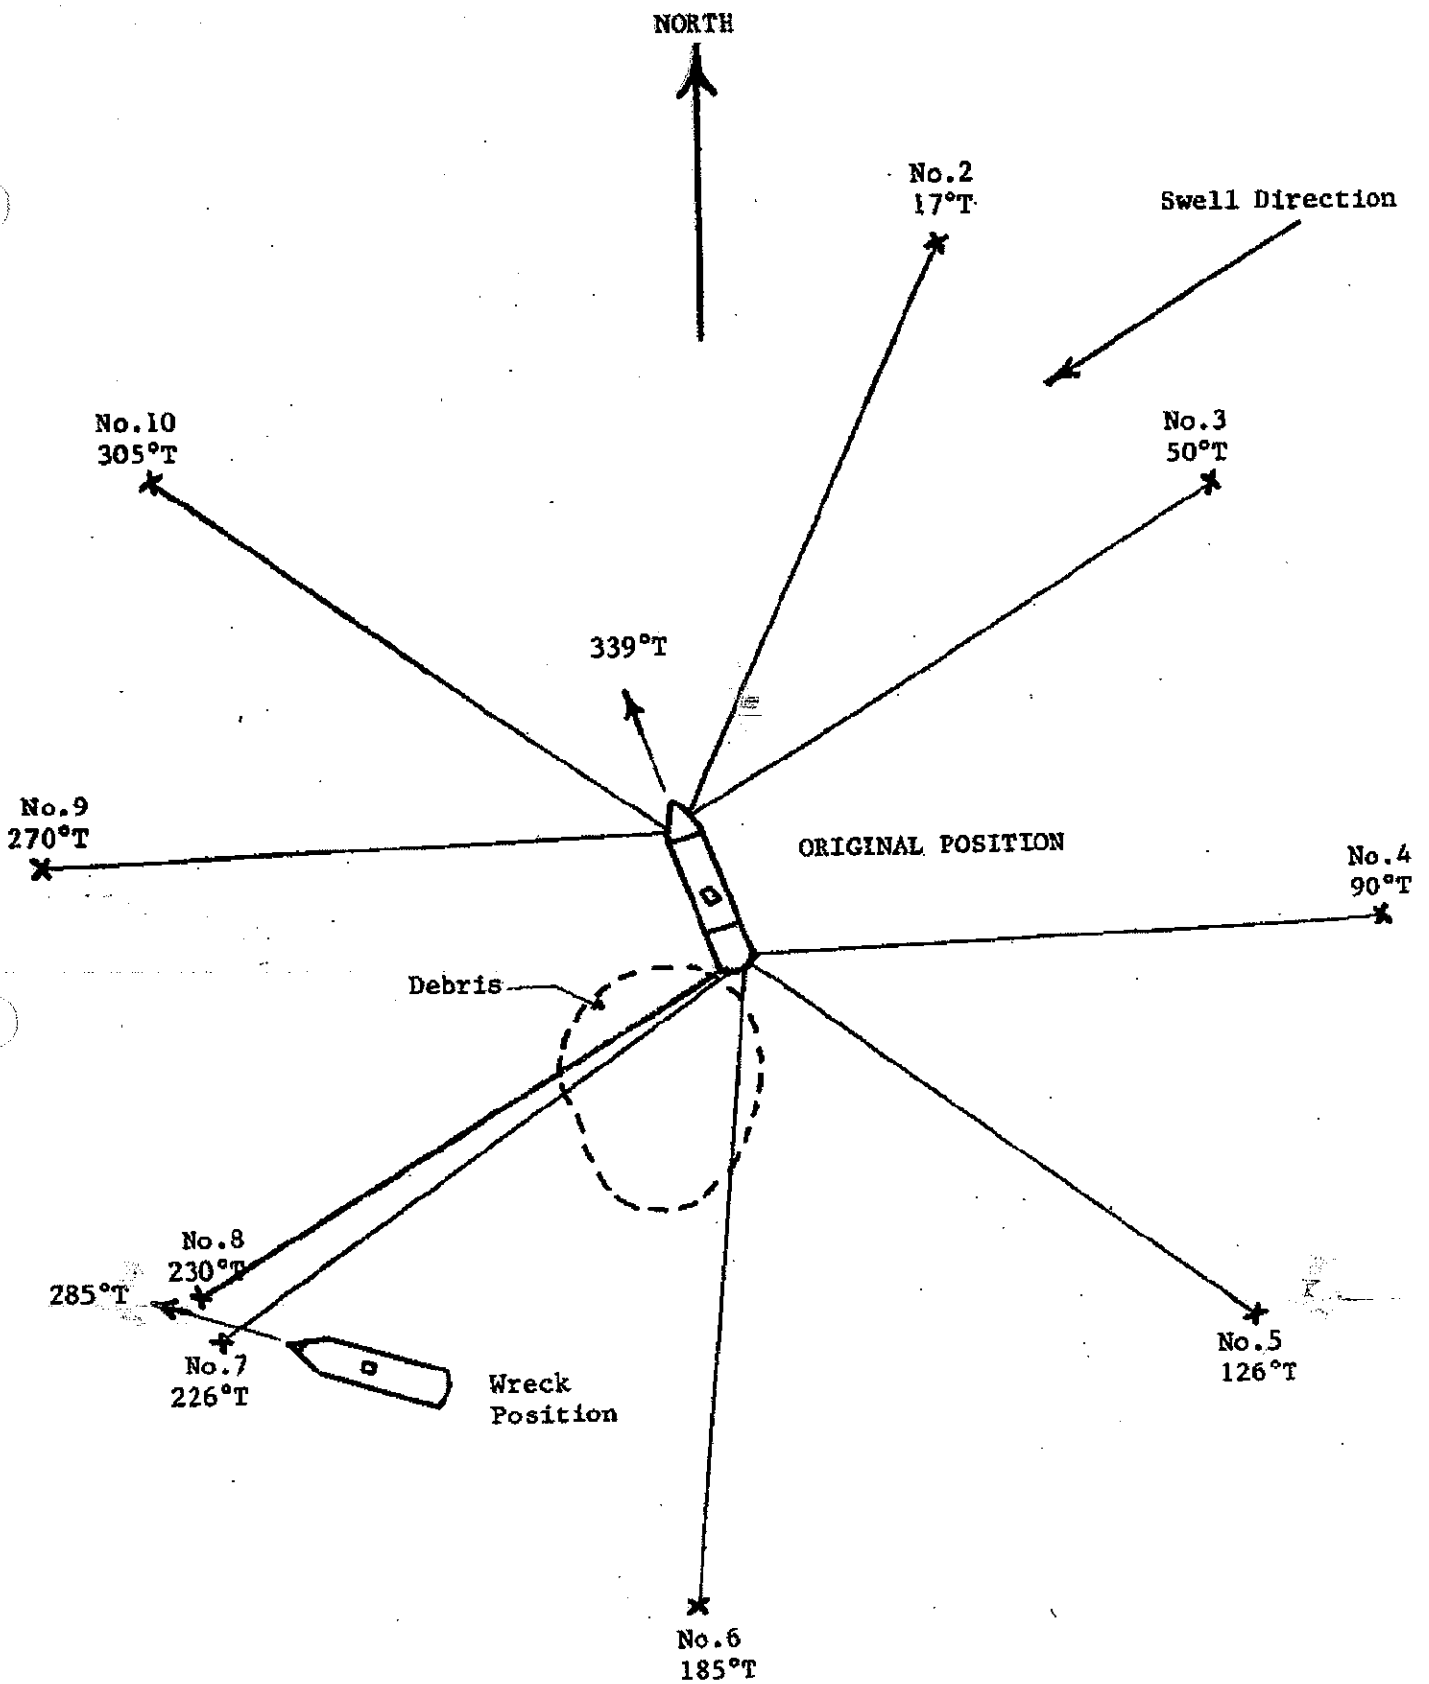
FIGURE 4: GLOMAR JAVA SEA's Anchor Pattern on 25 October 1983

The anchor pattern approximated pattern number 6 in the Marine Operations Manual and allowed for changes of approximately 30° to each side of the original heading to compensate, if necessary, for changes in weather or sea conditions, to limit vessel motions, or to reduce the strain on one or more chains. Such a change would be effected by slacking some chains and heaving in on others to pivot the vessel in place. This procedure was known to each of the Masters and the vessel's heading was changed from 335°T to 339°T sometime after it was anchored at the drill site.
